Memorandum

Subject: Lebanon Hills Regional Park Sustainable Trails Study

The Lebanon Hills Regional Park Sustainable Trails Study is being undertaken to provide a detailed assessment of existing trail conditions in the park, identify opportunities for improving the long-term sustainability of the trail system, and ensuring trail compatibility with the parks surrounding natural and cultural resources and high-quality trail recreation and nature-based experiences. The study is occurring in two phases, Phase I: Trail Assessment and Phase II: Recommendations and Implementation Strategy. This memo is a summary of the Phase I Assessment results. Phase II Recommendations and Implementation Strategy will be based on this assessment and be developed in Fall 2022. Outcomes of this study will help guide priorities, phasing, and funding needs for implementing future trail improvements.

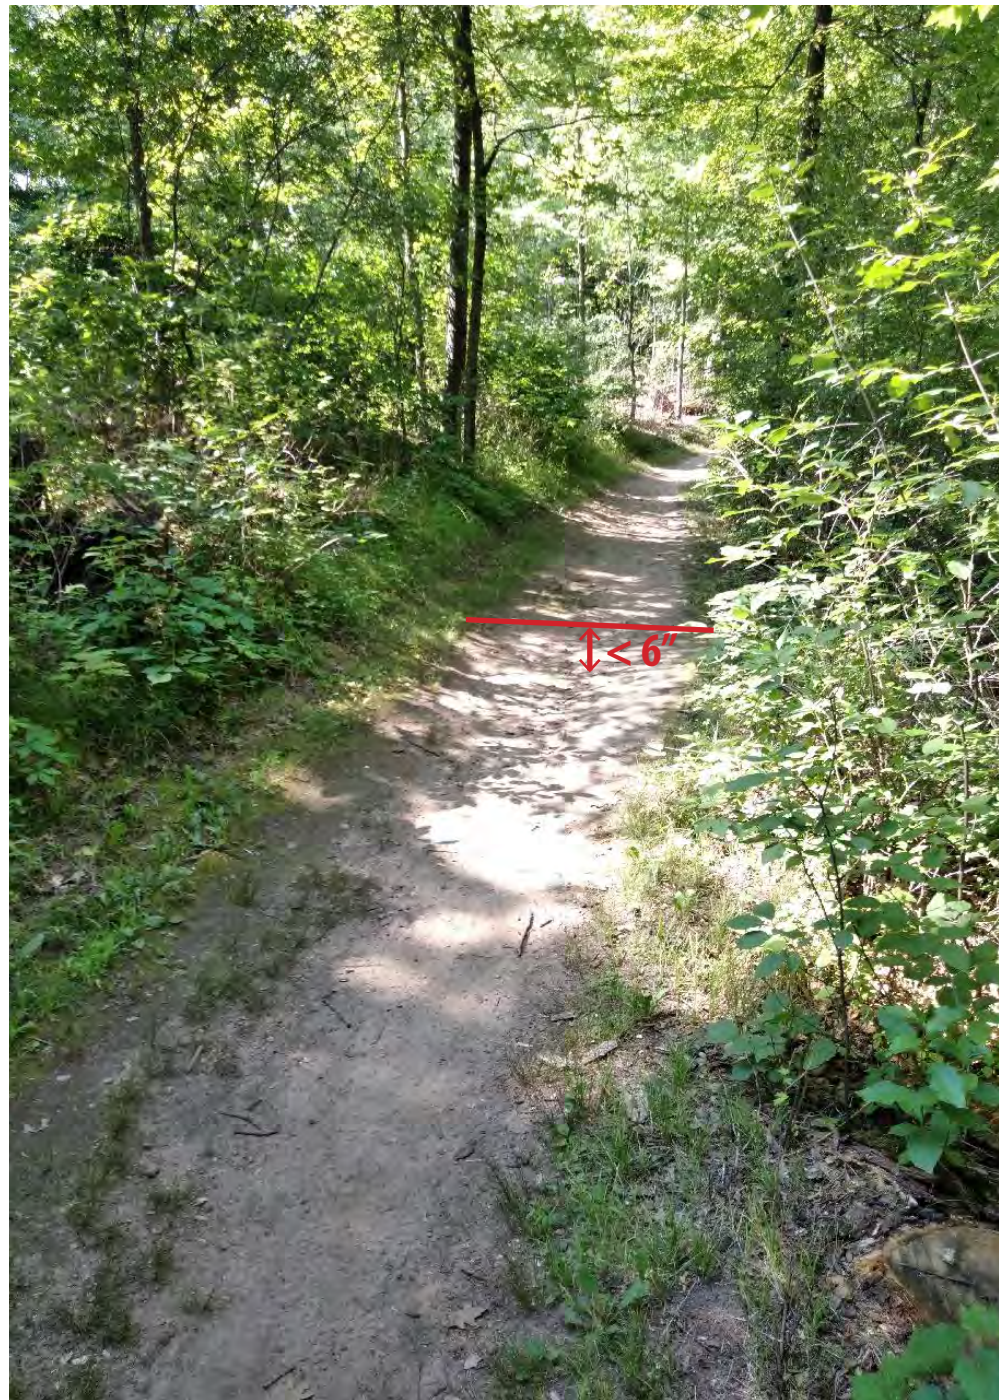
MINOR TRAIL EROSION

- Trail erosion less than 6" deep
- Trace amount of visual erosion

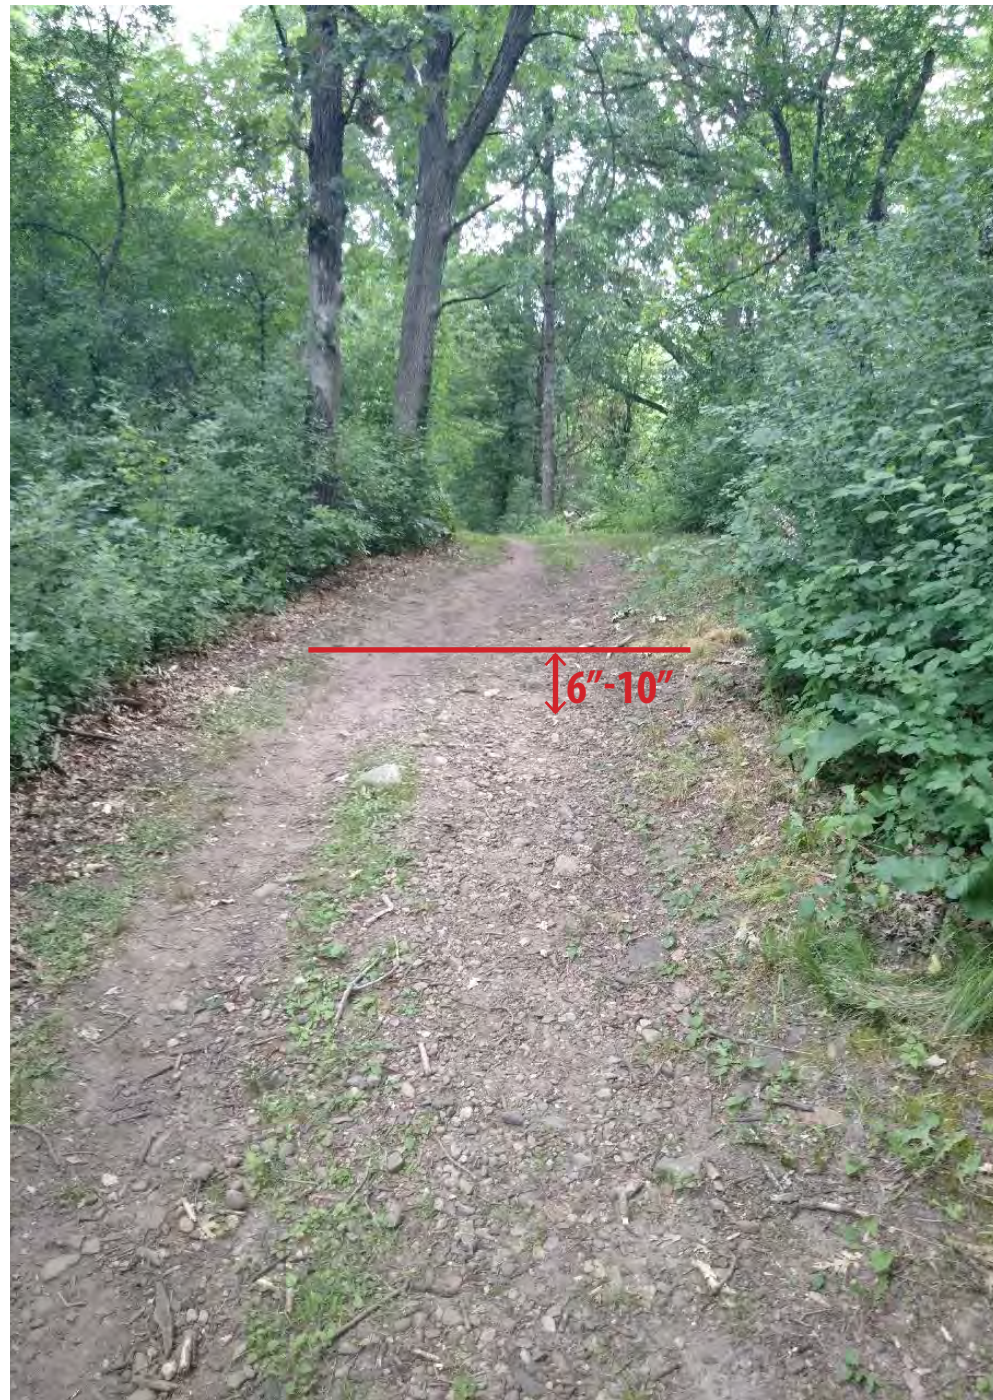
MODERATE TRAIL EROSION

- Trail erosion 6-10" deep
- Significant visual erosion but no deep gullies

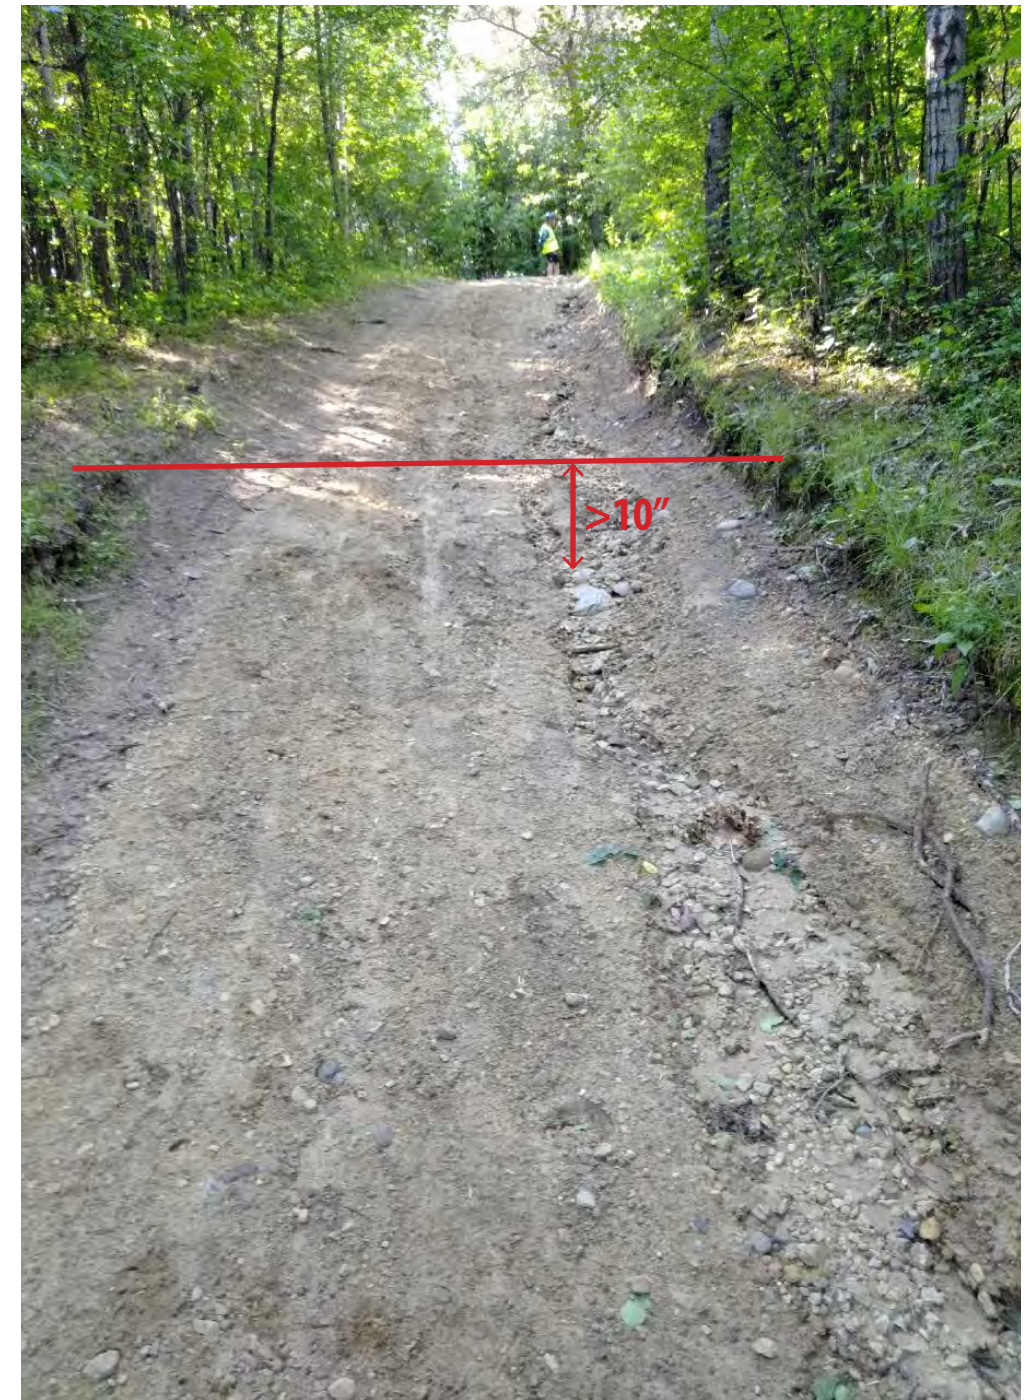
SEVERE TRAIL EROSION

- Trail erosion greater than 10" deep
- Deep gully erosion present

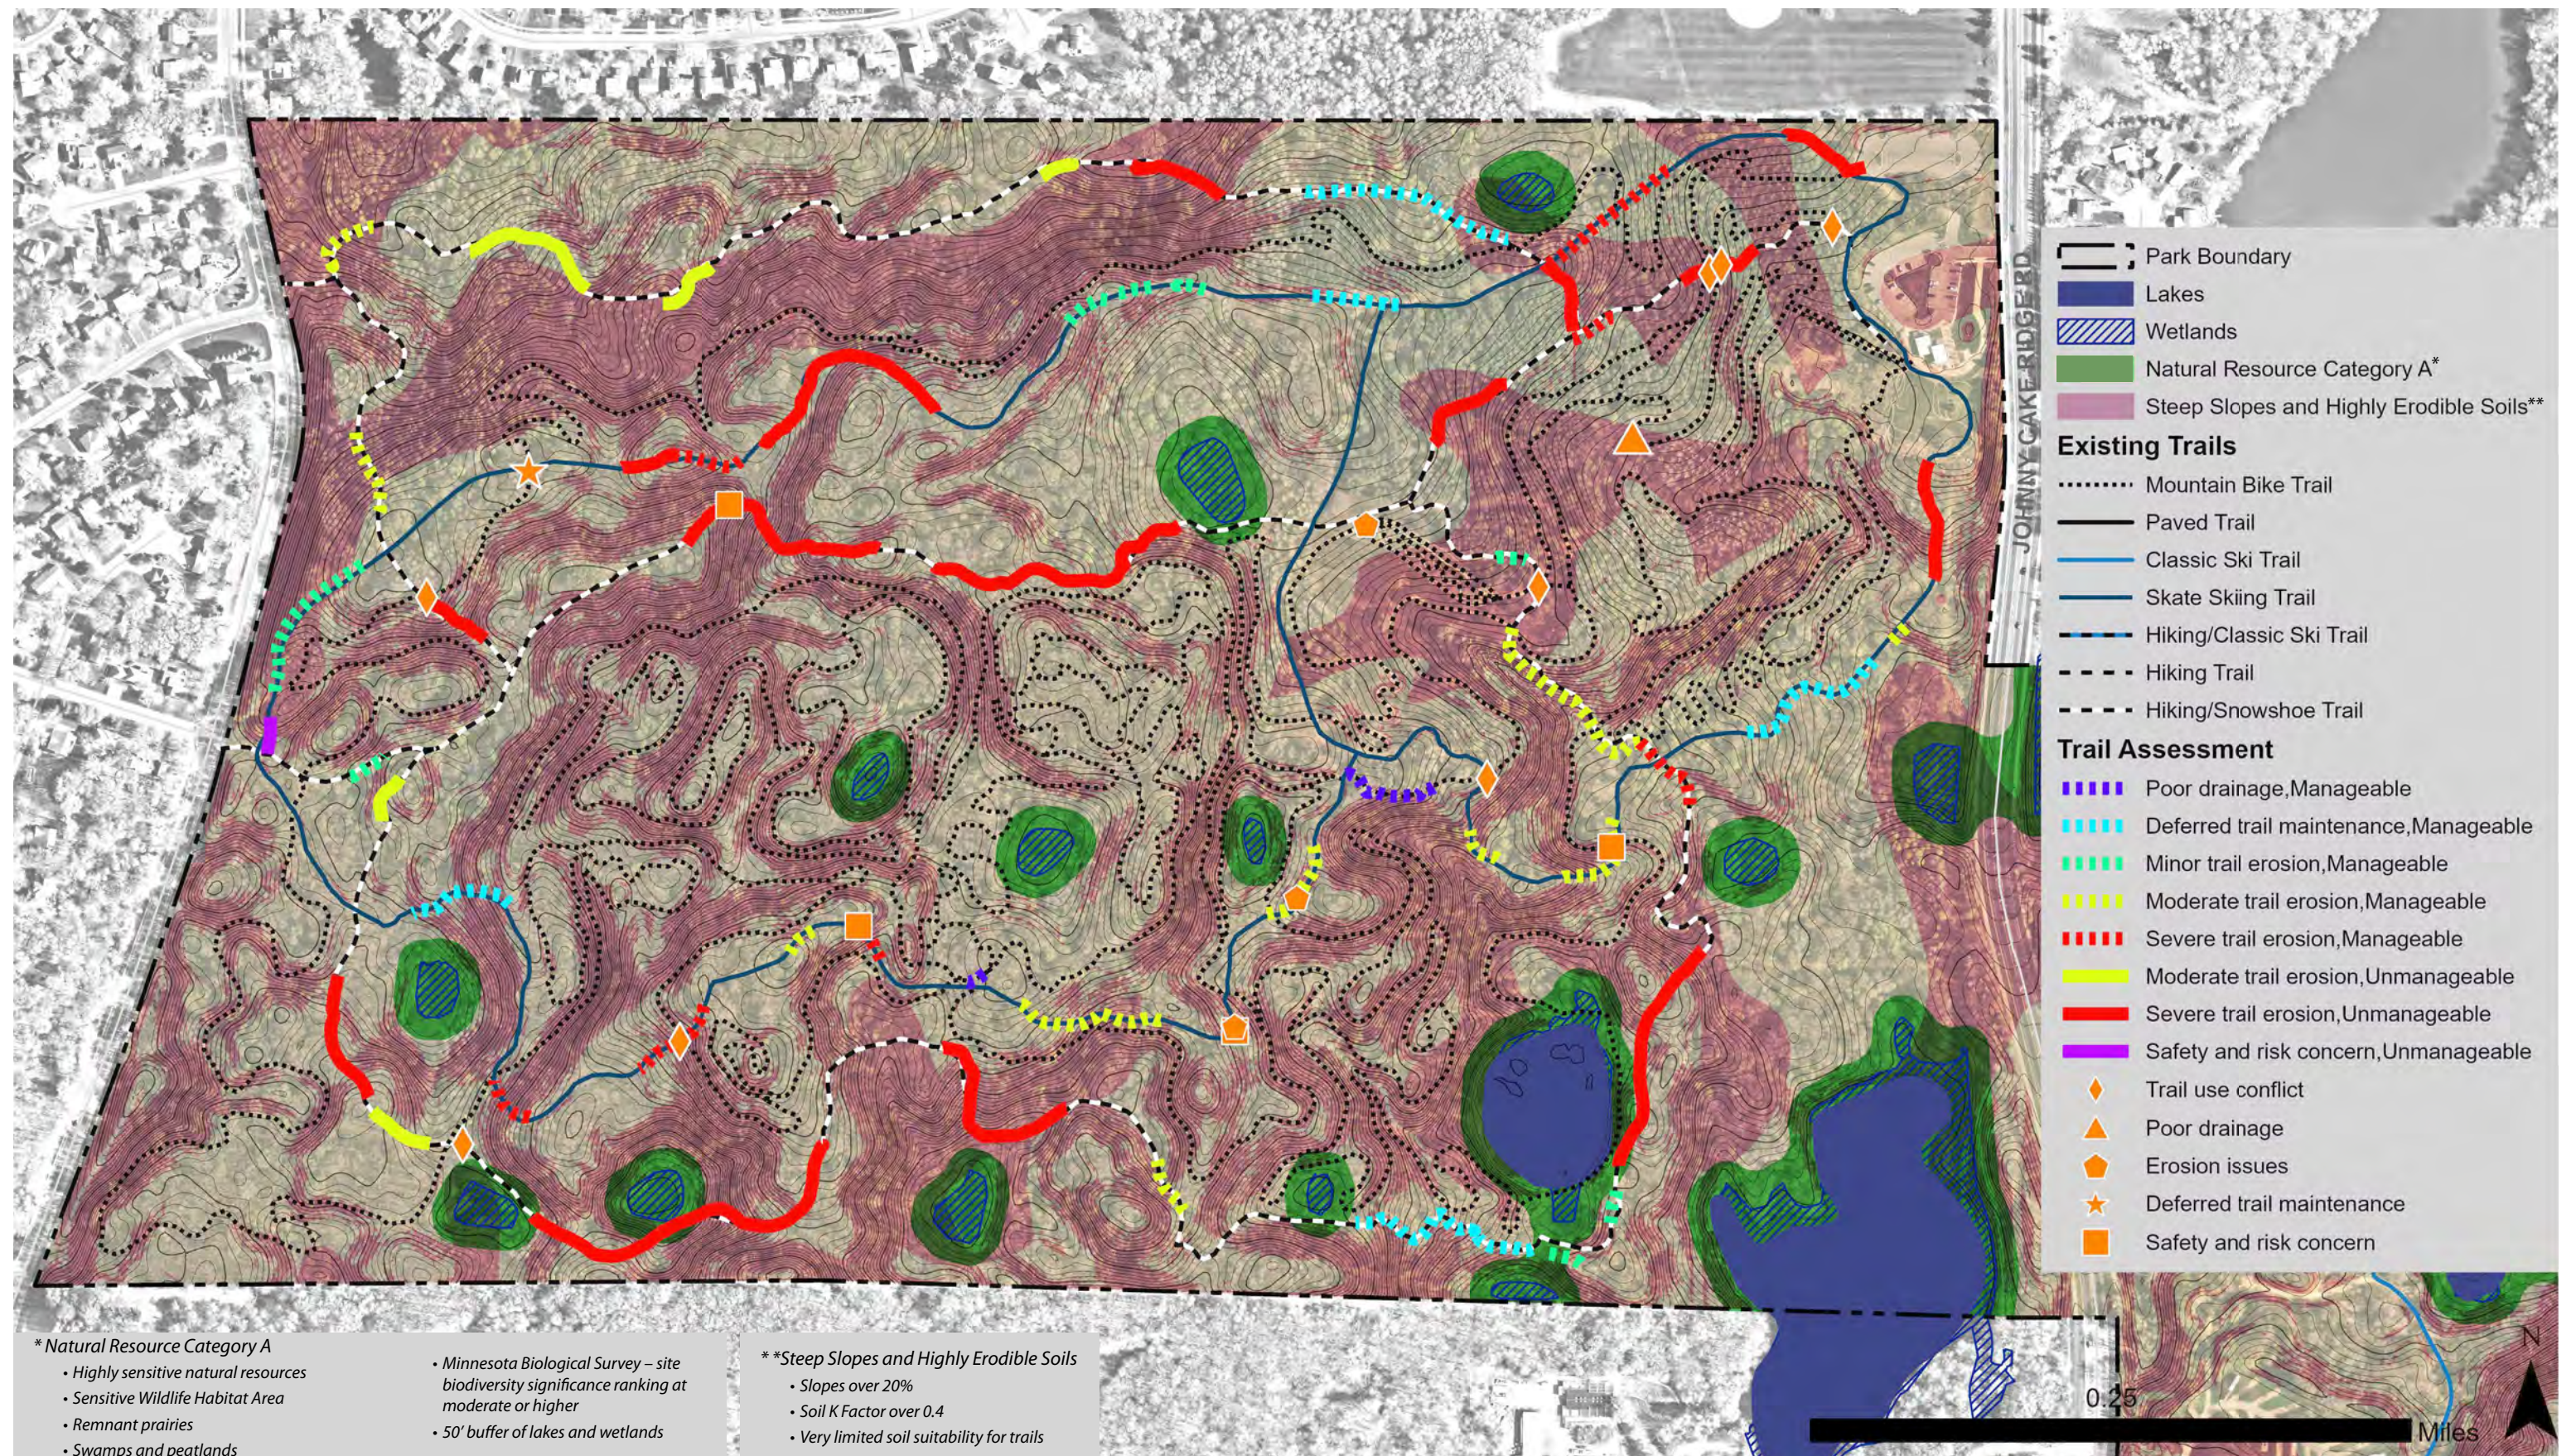
FIGURE 9: WEST SEGMENT TRAIL OBSERVATION MAP

- Removal of buckthorn vegetation at trail intersections and along trail edges to improve sightlines for trail users.
- Several high-speed intersections with the hiking/ski trail pose safety risks for trail users.
- The skills course is situated in a good location but needs improvements. Many features are outdated or in disrepair.
- The current trails system and skills course does not accommodate adaptive biker user needs.
- The trail segment known as the prairie area has constant erosion and needs continual maintenance.
- Embankment turns subjected to more frequent erosion and maintenance.
- MORC volunteer crews are doing an excellent job with ongoing regular maintenance and coordinating with County staff resources.

- The designated hiking and skate ski trail system in this area of the park have been subjected to more severe erosion over time based on their locations on steeper fall line alignments. Erosion issues include:
 - Deep gullies and washouts causing poor trail surface conditions that do not provide a high-quality trail experience for most users.
 - Severe trail erosion has caused runoff to some surrounding waterbodies and wetlands.
 - Many trail segments in need of realignment to prevent ongoing erosion issues.
- No accessible trails in this area of the park except for access to the trailhead restroom/shelter facility from the adjoining parking lot.

- Steep and challenging topography only accommodates advanced hikers and skate skiers.
- Tight corners on steep downhill are safety concern for beginner skiers.
- Lack of vegetative cover on trails has increased the erodibility of soils.
- Erosion control blanket placed on steep slopes has lost its effectiveness over time.
- Hiking trail network does allow loops of varying distances.

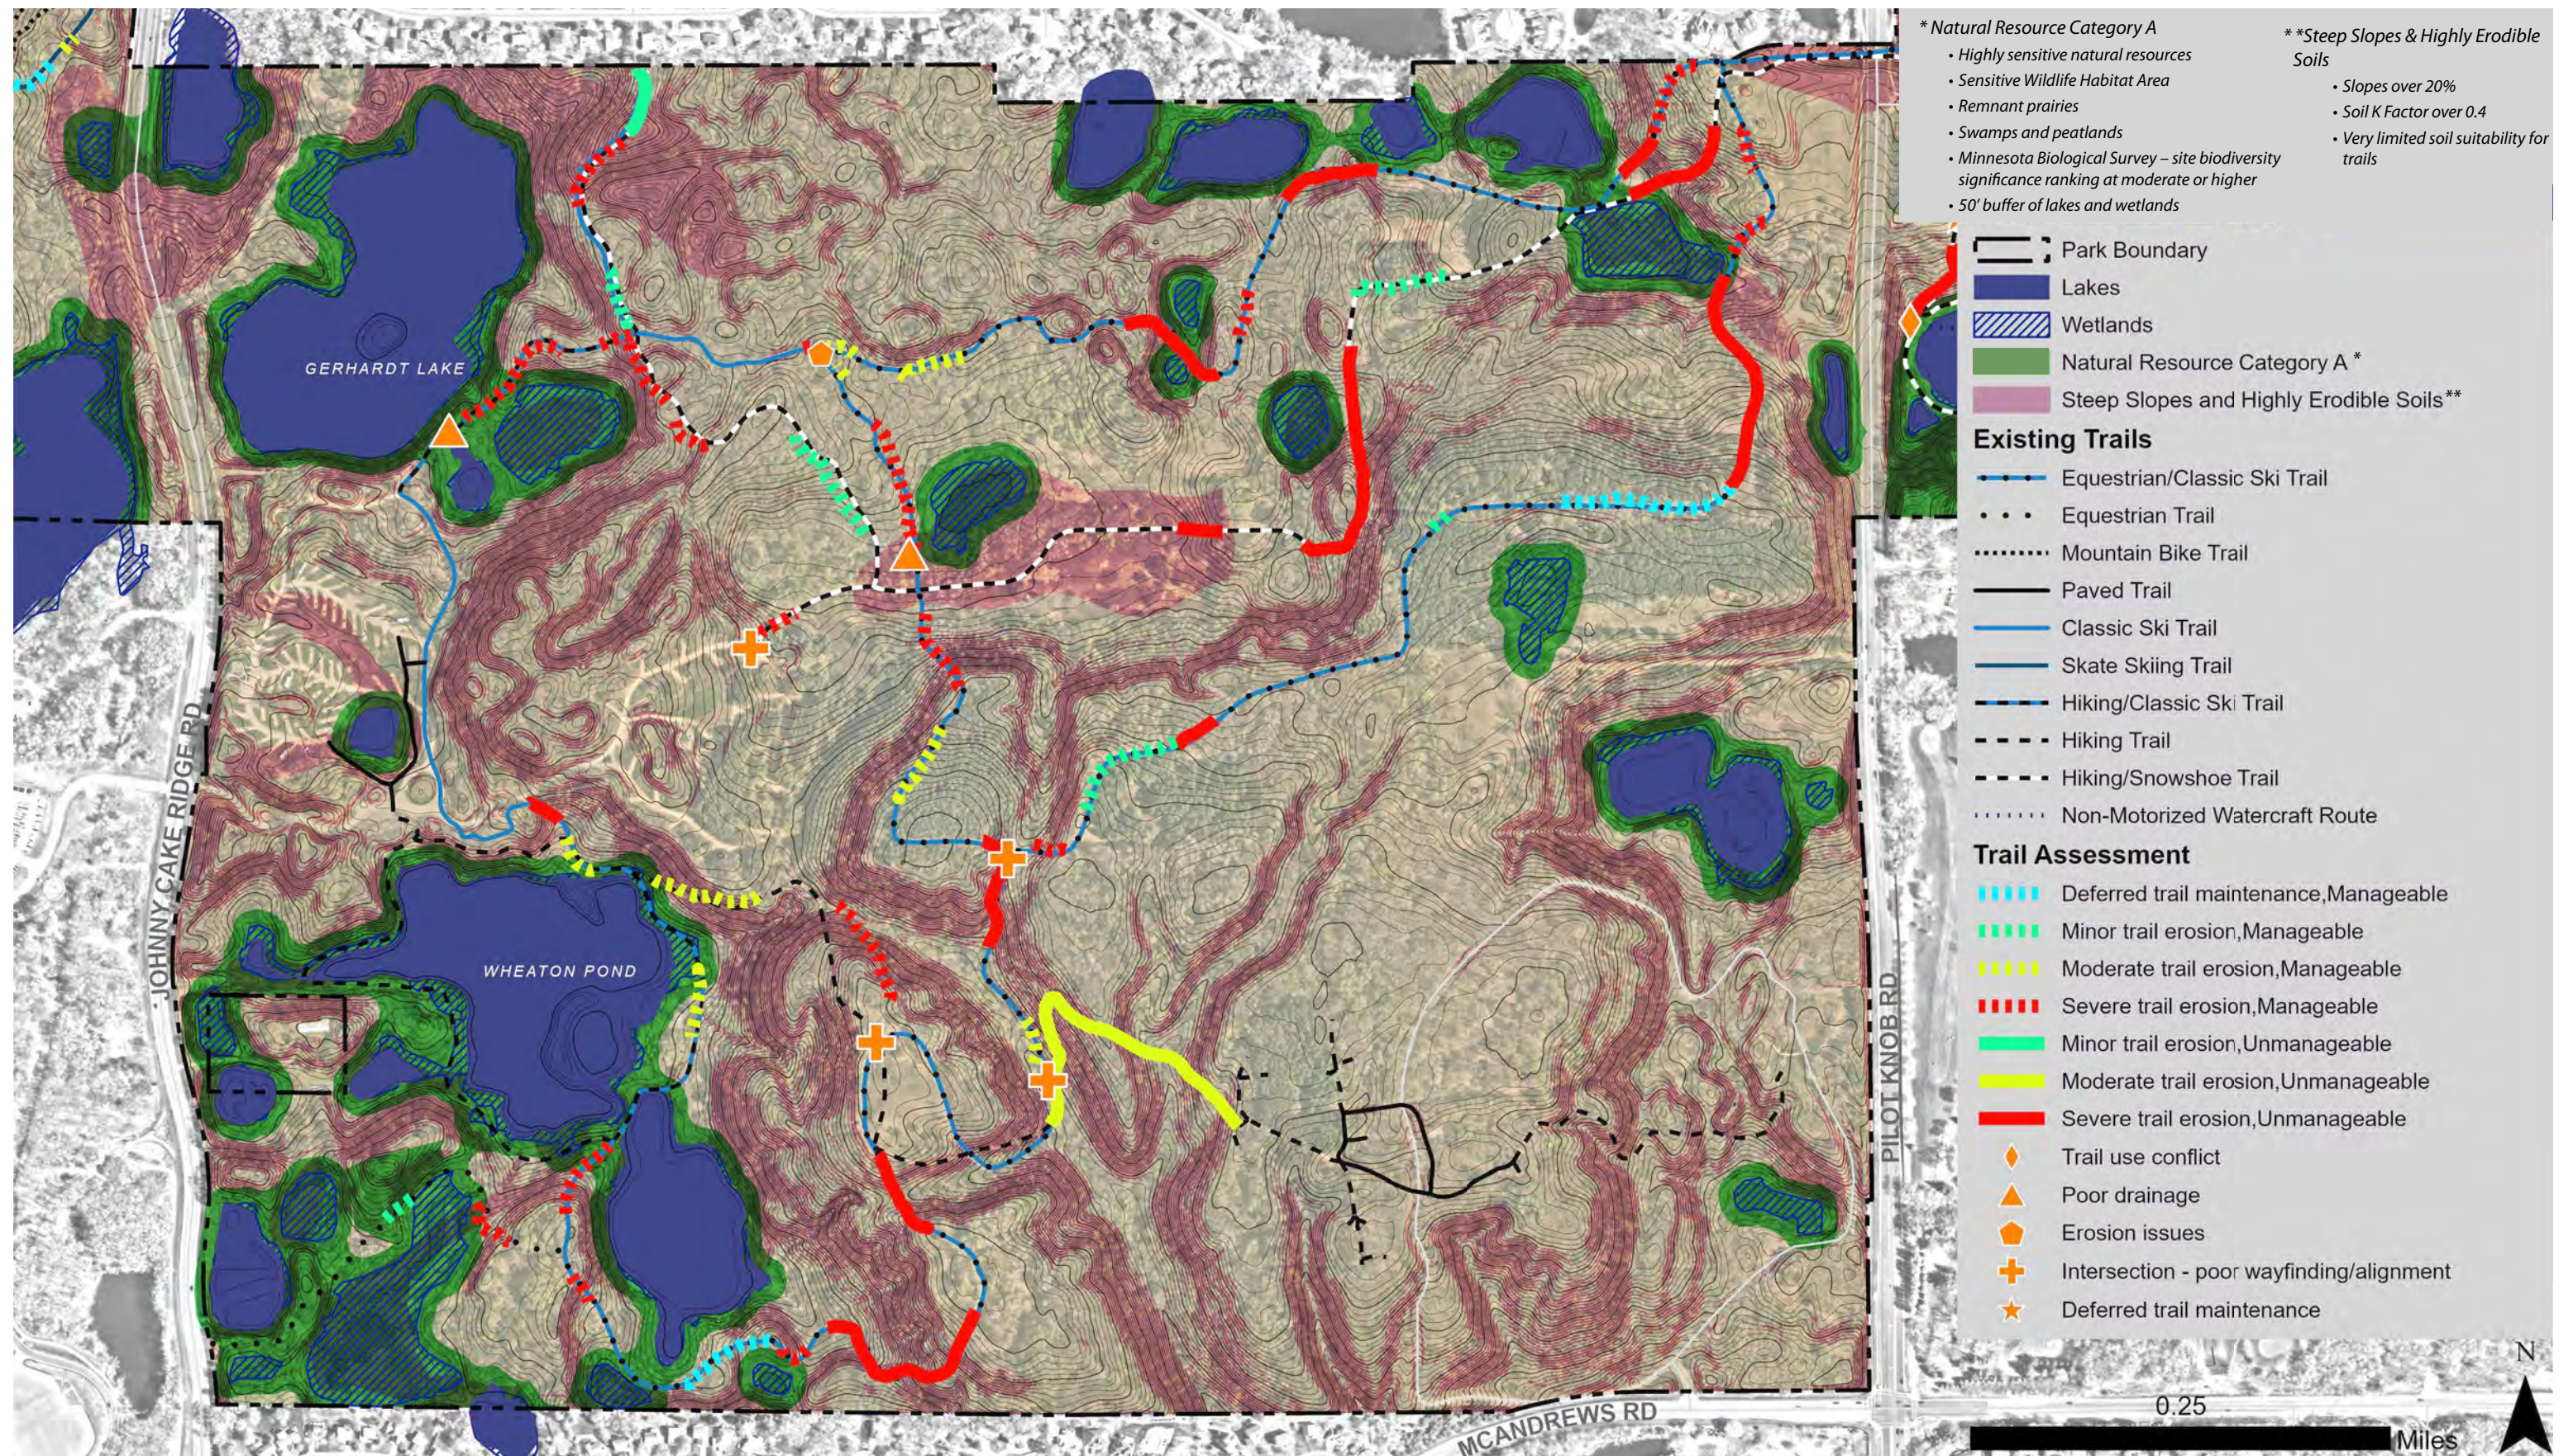
FIGURE 10: MIDDLE SEGMENT TRAIL OBSERVATION MAP

- Many steep fall line trails have moderate to severe erosion and direct runoff to lakes and wetlands.
- Lack of trail connections from Camp Sacajawea to other areas of the park. The current trail connecting the Camp with the middle segment hiking trails is poorly designed.
- Lack of a trail connection to the west segment to accommodate campground users.
- Lack of interconnected looped trails within the middle segment
- Confusing trail circulation and wayfinding east of Wheaton Pond.
- Lack of accessible trails.
- Presence of unofficial trails going down to lakes and connecting to adjoining neighborhoods.
- Trail around Wheaton Pond is less than 50 feet from the shoreline, but trail has minimal erosion and impacts.
- Hiking trail south of Gerhardt Lake extends past a high-quality natural resource (swamp and peatland) and exhibits severe trail erosion.

Many of the equestrian trails have been subjected to severe erosion because of poorly designed trails up steep topography in this area the park. Other observations included:

- Hikers, trail runners, and bikers were observed using equestrian trails.
- Some equestrian riders on the trail at the time of field evaluation commented they liked the steeper terrain in this area of the park for training and conditioning their horses.

- Equestrian use of trails was observed to be higher at the east segment of the park during the field evaluation.
- Most equestrian trails are not in a sensitive natural resource area but the spur trail to Johnny Cake Road extends along a remnant prairie and a swamp and peatland.

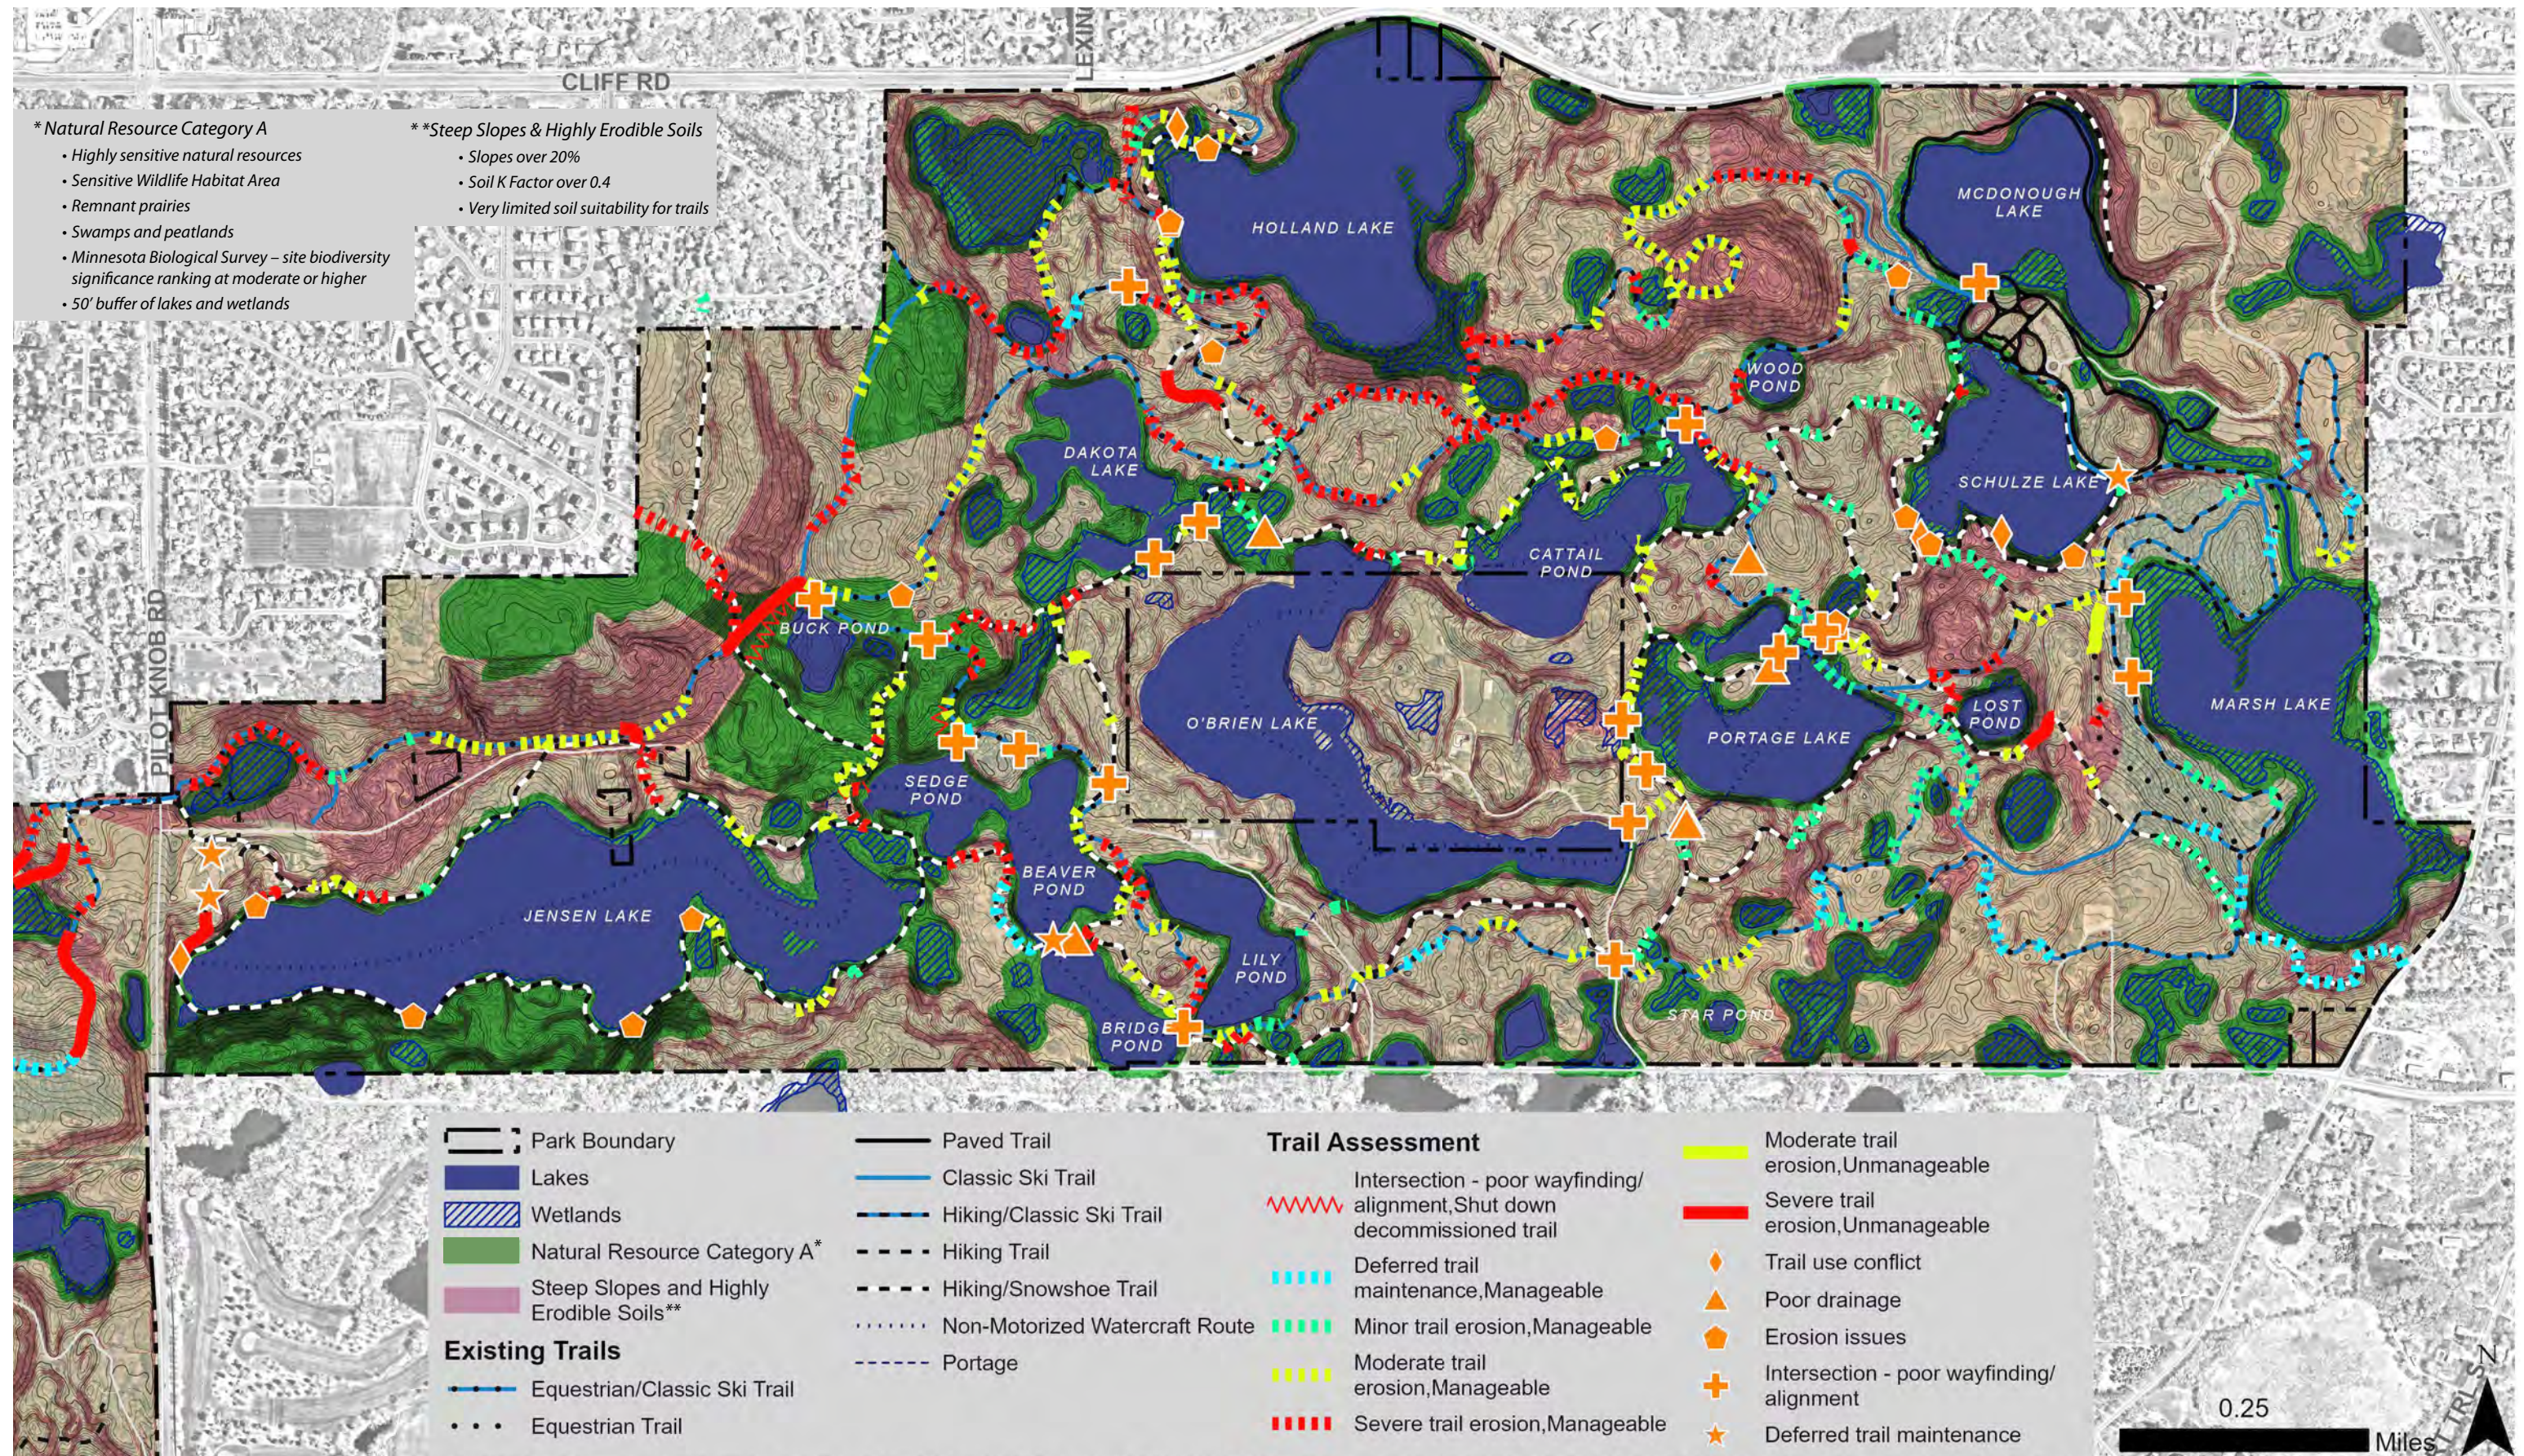
FIGURE 11: EAST SEGMENT TRAIL OBSERVATION MAP

- Most trail erosion issues were moderate and minor in this segment of the park.
- Trails are well aligned with topography.
- Most trail segments with erosion can be corrected through sustainable trail design and maintenance methods that diverge water off the trail in more frequent intervals because trails are generally well aligned with the topography.

- Trail connection transitions to boardwalks need to be improved to minimize tripping hazards.
- Boardwalks are slippery when wet, especially in the winter when ice is present.

- Boardwalks around Jensen Lake have settled creating drainage issues under decking substructure.
- Decommissioned trails and maintenance roads not clearly identified causing wayfinding confusion.

- Lack of accessible hiking trail loops from Jensen Lake Trailhead and Holland Lake Trailhead.
- Lack of accessible trail identification signage.
- Some popular trails such as the Jensen Lake Loop are narrow and do not allow for travelers going different speeds to easily pass.

- Lack of formal connection to park from neighborhood could cause unofficial trails being developed through the remnant prairie north of Buck Pond.
- High concentration of trails through the sensitive wildlife habitat area.

- Trails well aligned with the topography but lack provisions for controlling runoff down or cross slope of trail.
- More equestrian users observed using the east segment equestrian trails during the field evaluation.
- Most existing eroded trails segments can be corrected without rerouting.
- Decommissioned trails or maintenance roads look like equestrian trails and cause confusion for users.
- Wayfinding is lacking at some trail intersections.
- Much of trail system located in old growth/interior forest areas

- The paved trails were generally in good condition.
- McDonough Lake trail provides accessible trail loop.
- Some root intrusion of paved trail around the Jensen Lake Trailhead.

- The portage trails were generally in good condition.
- Low use foot traffic on most portages has minimized erosion issues.
- Some steeper trail access alignments to shoreline edges have caused some sediment run-off into lake basins.
